MORGAN BRIDGE

HAER VT-33

MORGAN BRIDGE HAER No. VT-33

Description¹

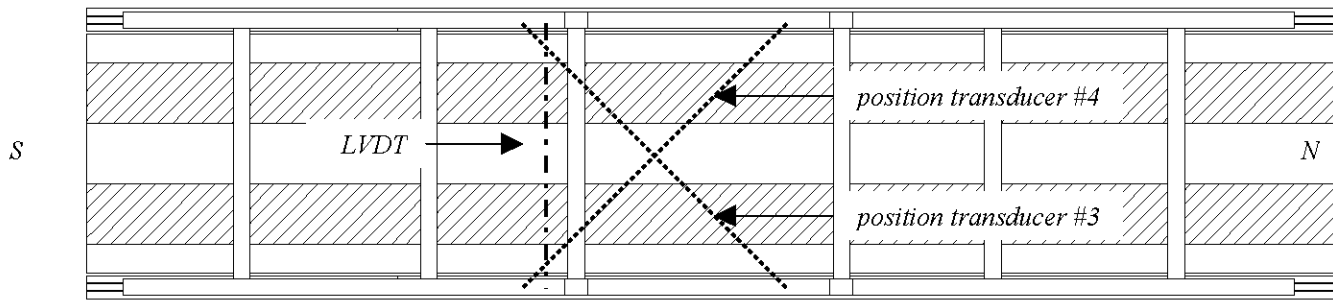
In general, truss bridges are analyzed as two-dimensional structures, with the assumptions that there are no significant eccentricities in either the structure or the loads, and that the trusses are adequately braced against lateral forces. For the Morgan Bridge, differences between the east and west trusses, such as the triangular gussets in two corners, make the occurrence of significant eccentricities a realistic possibility. To investigate this, two position transducers and an LVDT were connected between the east and west trusses to measure relative out-of-plane displacements under vehicular loading. The locations of the instruments are illustrated in Figure 43. Figure 44 is a photograph of the assembly.

Figure 43. Plan view of bridge, showing locations of the position transducers and LVDT

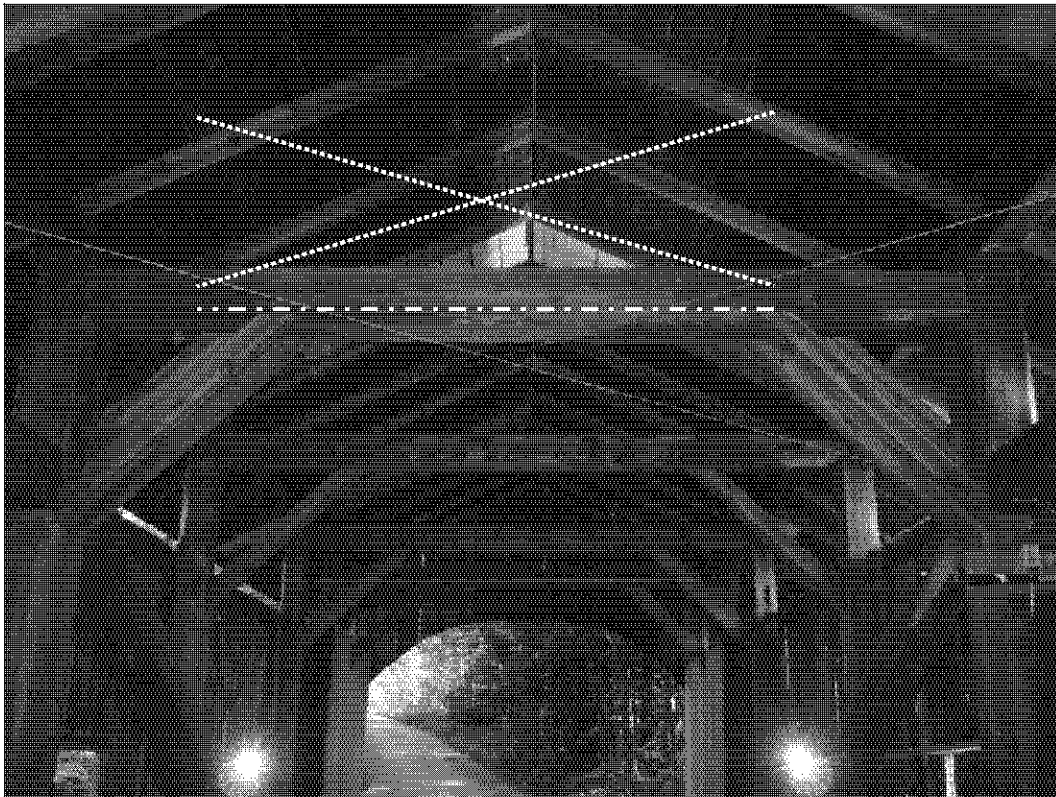
Figure 44. Photograph of test assembly (looking south)

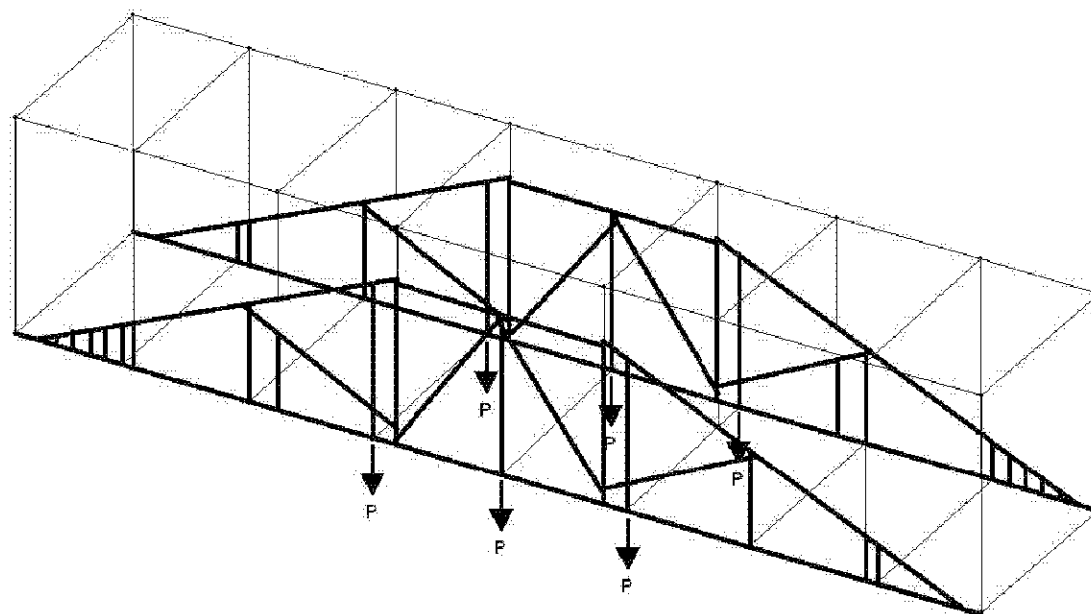
To evaluate the experimental results, a three-dimensional computer model was developed, based on the two-dimensional model, but with the addition of floor beams and roof truss members. Field measurements were not made of the east truss, but a triangular steel plate was observed at its south end, identical to the one at the north end of the west truss. Assuming that this would be the most significant contributing factor to the results of the model, the east truss was modeled as a 180-degree rotation of the west truss about the vertical axis. The transverse members of the roof truss were included in the three-dimensional model. To account for the apparent stiffness of the knee braces, the joints between the roof members and the trusses were assumed to be fixed. The floor beam connections to the trusses were modeled as pins, assuming that no moment could be transferred through the metal rod connection. The three-dimensional model is shown in Figure 45.

Figure 45. Three-dimensional MASTAN model of Morgan Bridge with truss loading shown for truck at position C

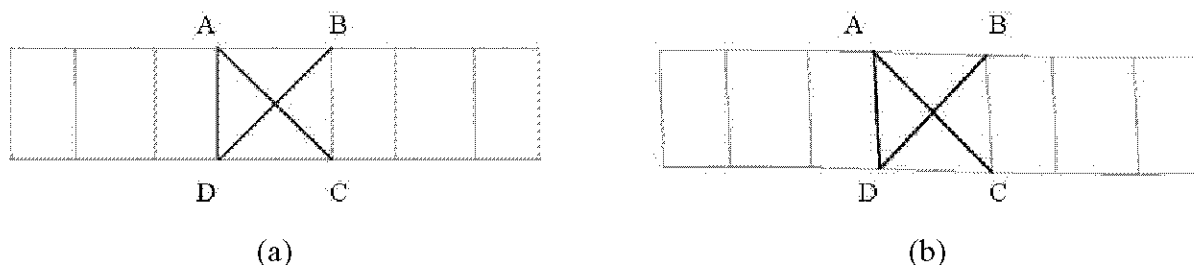
The model was loaded just as for the two-dimensional model, with the appropriate concentrated forces applied to the panel points. Since the floor beams were pin-connected to the truss, loading the truss anywhere along the floor beam would be suitable, since no moment from the floor beam could be transferred to the truss. Figure 46 illustrates the undeflected shape of the roof truss (as viewed from above) and the deflected shape of the roof truss when loaded at position C. The darkened lines represent the LVDT and position transducer locations. Table 6 contains the results of both the experimental tests and the computational model.

Figure 46. (a) Undeflected and (b) Deflected shape of roof truss with live load at position C
